# SERVICE BULLETIN

No. 389

Piper Aircraft Corporation

Subject: Bridle Cable and Bridle Cable Clamp Inspection; AltiMatic V and AltiMatic V Flight Director Series Automatic Flight Control Systems

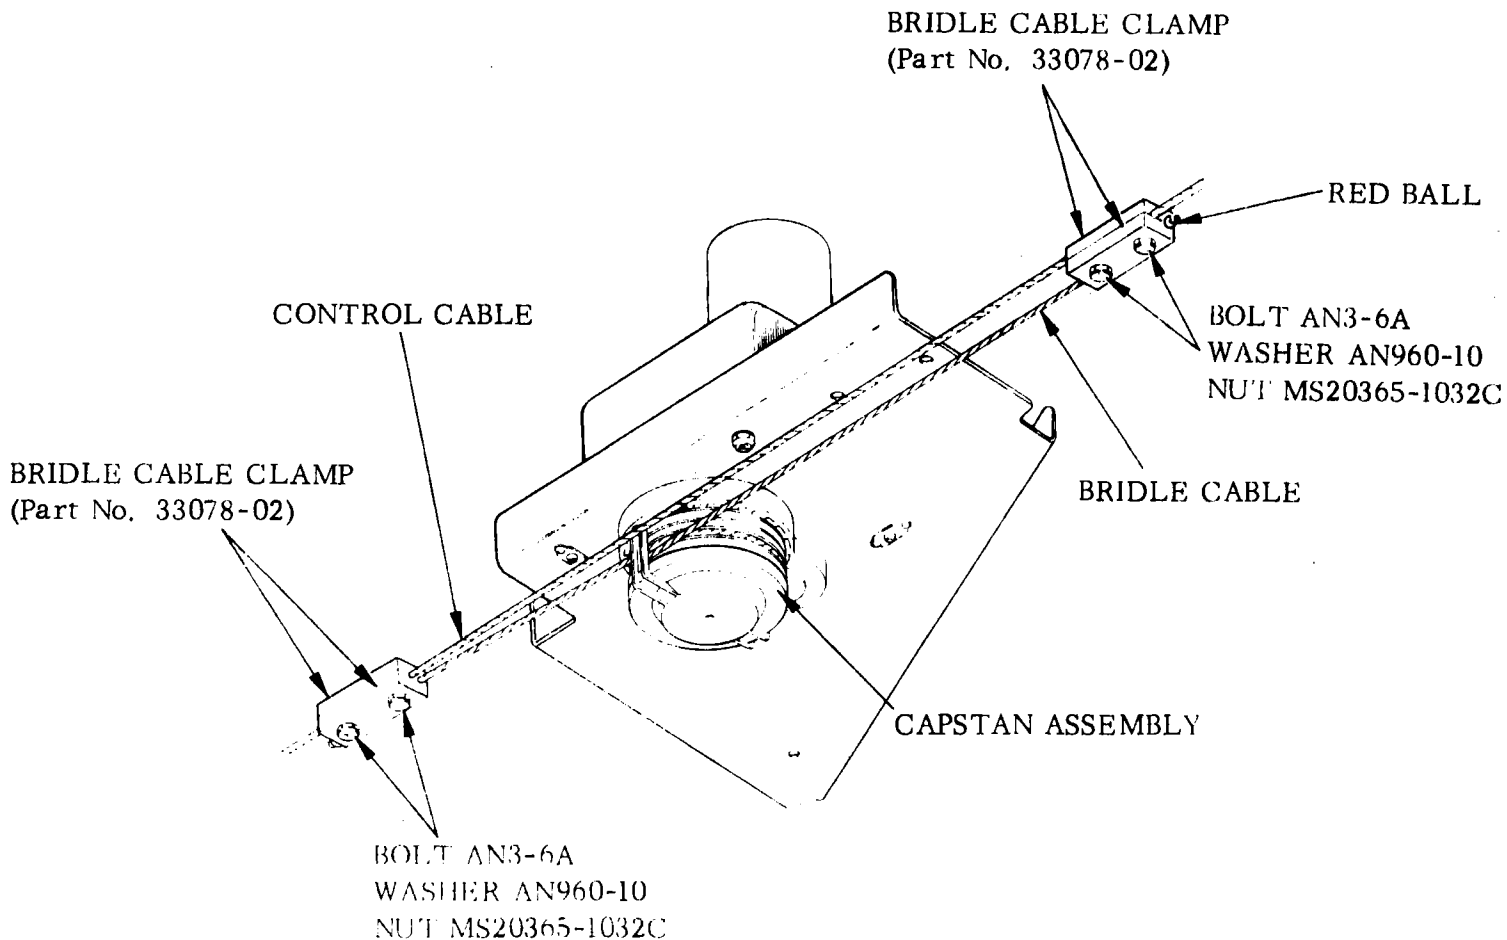
TYPICAL BRIDLE CABLE INSTALLATION  
(PA-31 Series Roll Servo Shown)

Purpose: Two reports have been received which described the slippage of the roll servo bridle cable clamps on the above referenced aircraft. It appears possible that the lock nuts used in the bridle cable clamp assemblies may have loosened, causing subsequent bridle cable clamp slippage. This condition can normally be prevented by routine inspections of the Automatic Flight Control System components as specified in the appropriate Piper periodic inspection forms, airplane service manuals and appropriate Automatic Flight Control System service manuals.

2. Loosen the nuts on the bridle cable clamps - one at a time, then retighten; ascertain that the MS20365-1032C nuts retain their self-locking capabilities. If the nuts run freely on the AN3-6A bolts, replace nuts as required.

3. Check the control cable and bridle cable tension in accordance with the Roll and/or Pitch Servo Capstan Assembly Installation Instructions in the appropriate V Series Service Manual.

4. Torque the bridle cable clamp bolts to 23 + 2 inch-pounds, above the nut running torque.
5. Check for proper position and security of bridle cable clamps and for proper servo function as outlined in the roll and/or pitch servo installation instruction in the appropriate V Series service manual.
